Gelati Monastery Complex

The Church of the Nativity of the Virgin Mary

The western window niche of the dome

Detachment of the painted wall painting fragment

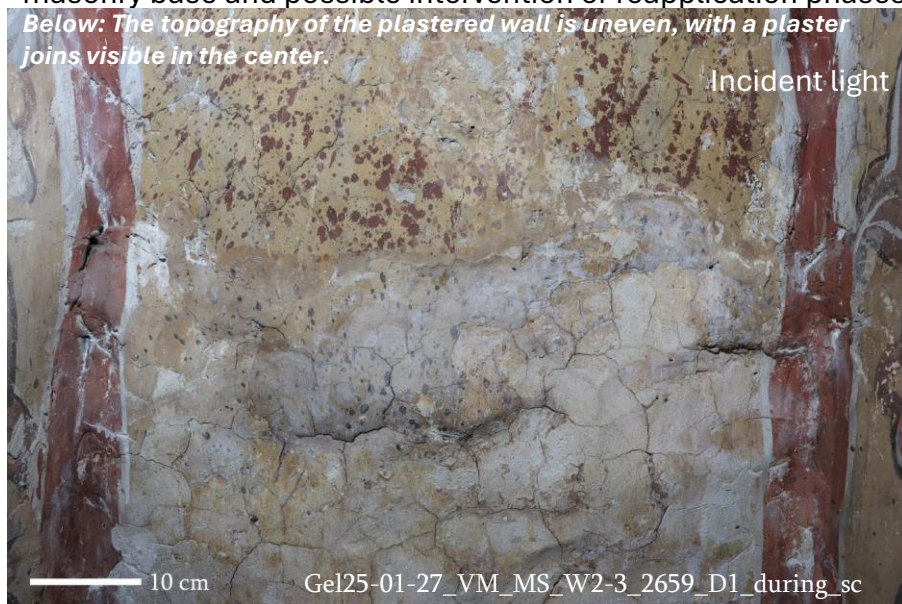
The plaster topography is uneven, conforming to the irregular brick substrate beneath. A horizontal plaster join is visible near the center of the section, while vertical plaster joins are located at the edges. The plaster thickness varies significantly across the surface, ranging from 0.3 cm to 3 cm, with the thickest applications found at the center of the panel. These variations suggest compensatory application over an irregular masonry base and possible intervention or reapplication phases.

Below: The topography of the plastered wall is uneven, with a plaster join visible in the center.

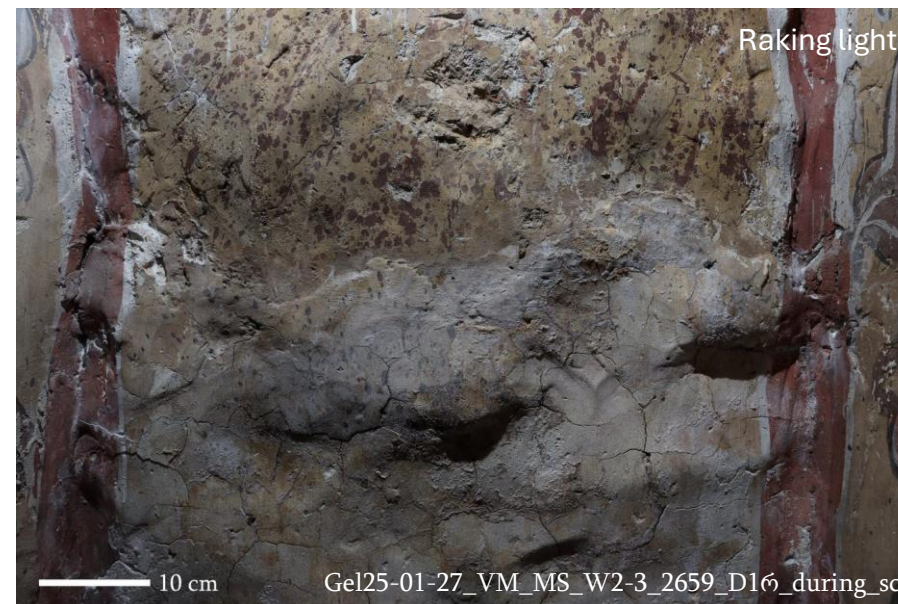
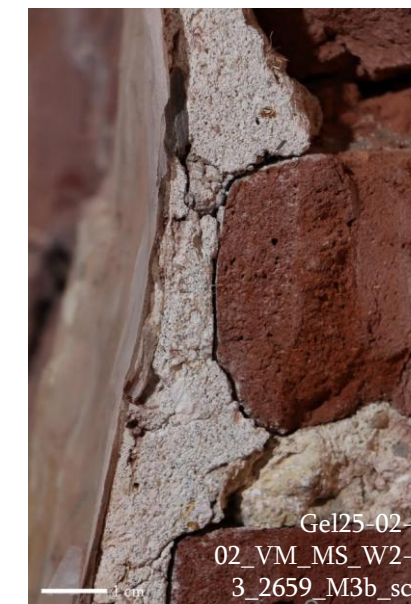
Left: The lower part of the west window of the dome is built with half a meter thick bricks. The surface is plastered and painted.

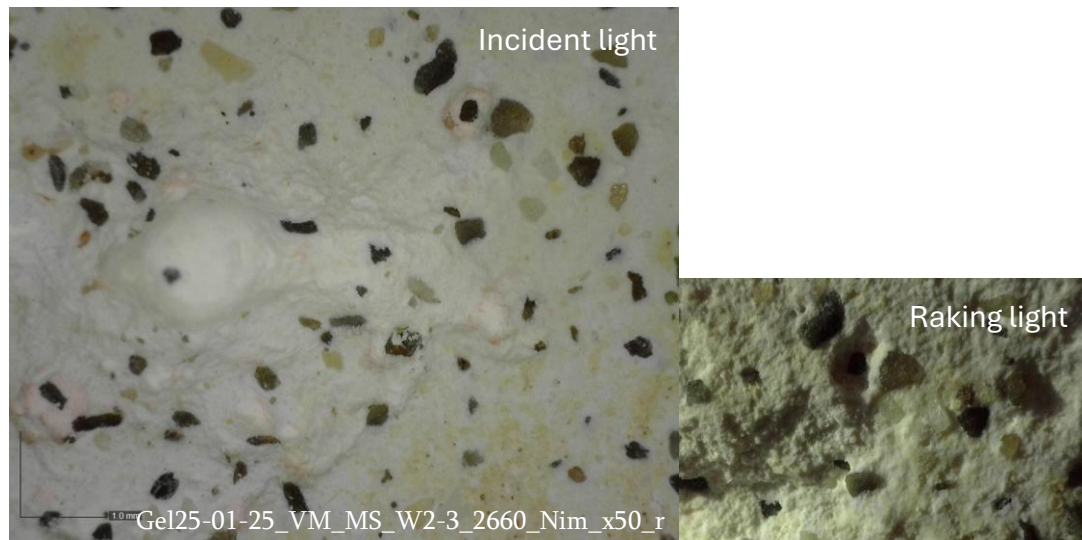
It is noteworthy that the plaster composition differs above and below the central horizontal join. The lower plaster layer, which is damaged, is characterized by a grayish-white tone and contains polymictic sand—a mixture of medium- and fine-grained particles in various colors. The Plaster thickness in this layer varies from 0.3 cm to 3 cm, consistent with the overall irregular application observed in the study area.

Above: Microscopic composition of the aggregate (at 50x magnification). The white binder uses inorganic sand aggregates of various colors and morphologies.

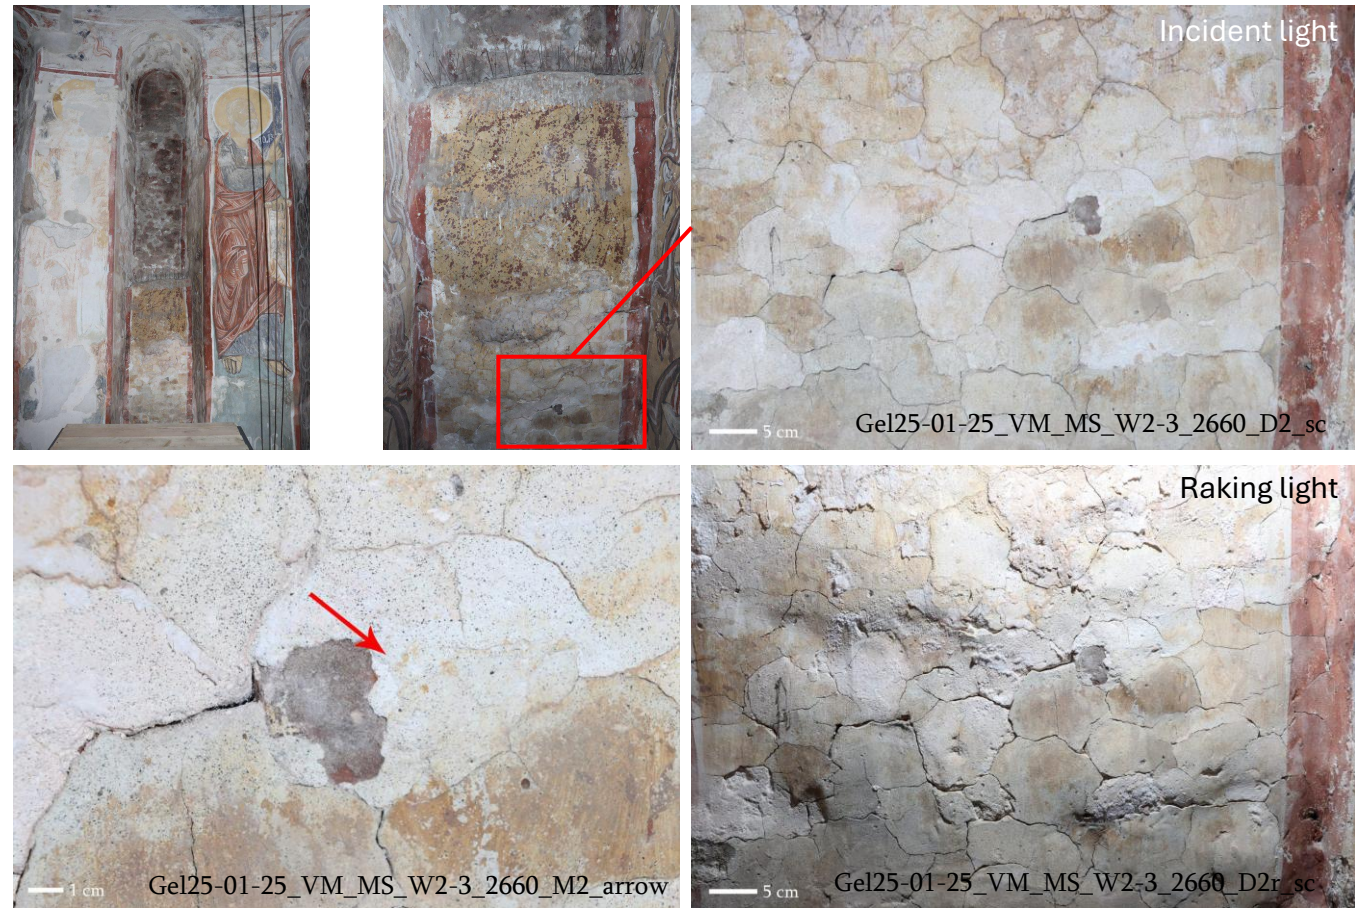
Above: Fragment of a built-up window. A thin layer of plaster below the plaster join, which is applied to a brick base. The red arrow indicates the location of the microscopic study of the plaster.

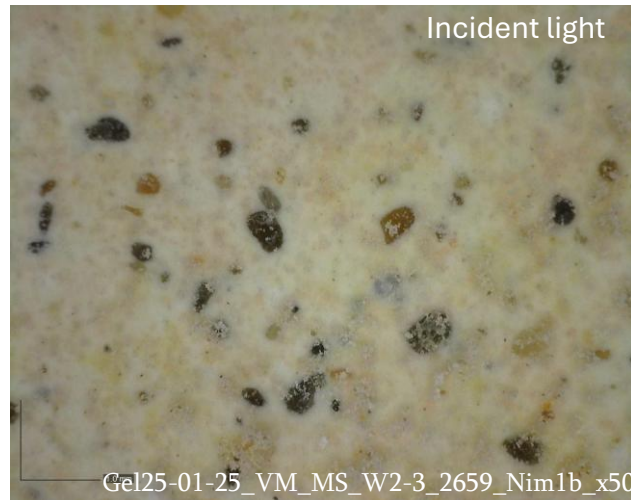
In the removable section of the window, the plaster above the horizontal join is composed of grayish-white polymictic sand, containing a mixture of coarse, medium, and fine grains in various colors, bound with a white binder. Within the cross-section, organic inclusions—specifically yellow-colored plant fragments—are also observed, suggesting the use of traditional or natural additives in the plaster mix.

Above: Composition of the cut (at 50x magnification). Inorganic sand aggregates of various colors and morphologies are used in the white binder.

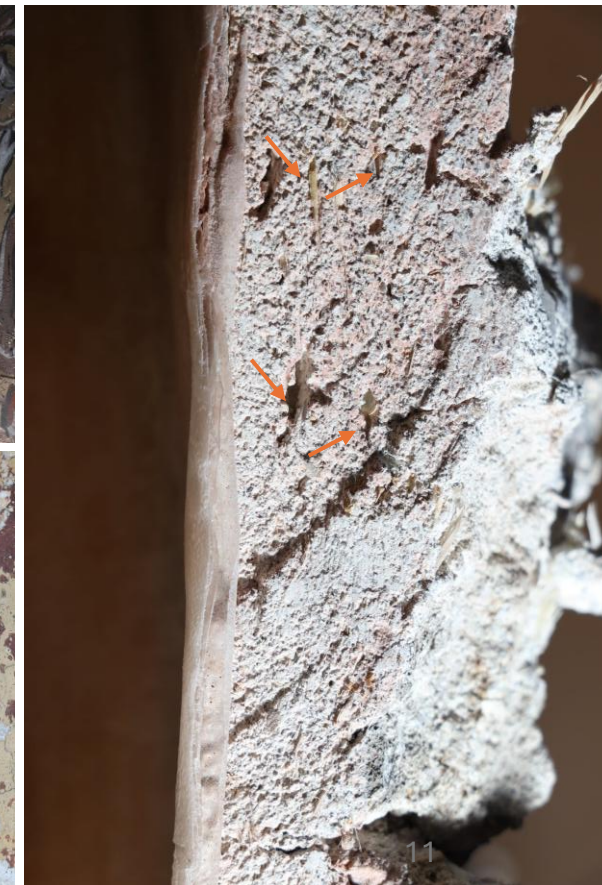
Below: Fragment of the cut (on the upper side of the join). The orange arrow indicates a yellow-colored plant inclusion.

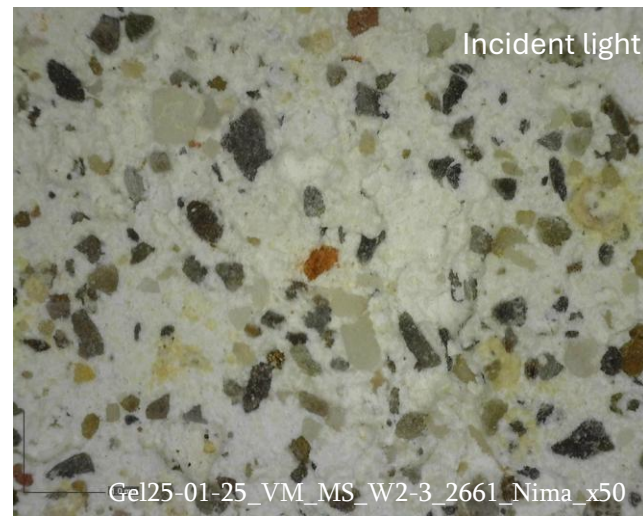
The plaster on the upper side of the join on the window wall differs notably from the plasters found on both the upper and lower sections of the built-up window. This plaster is grayish-white and composed of a high concentration of polymictic sand, with a dominance of coarse and medium grains in various colors, bound with a white binder.

Above: Microscopic composition of the aggregate (at 50x magnification). The white binder uses large aggregates of inorganic sand of various colors and morphologies.

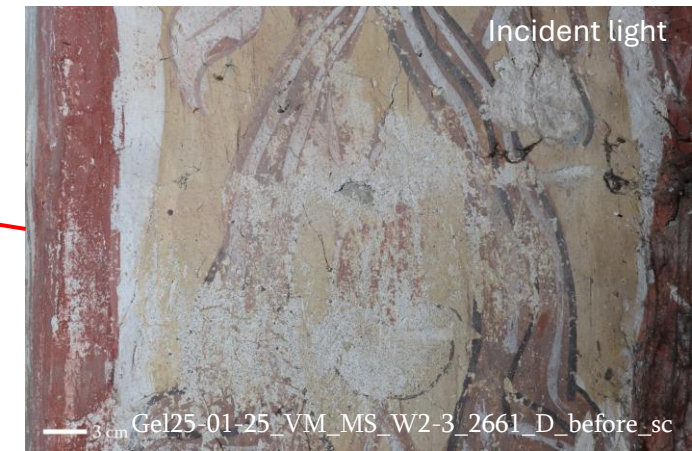
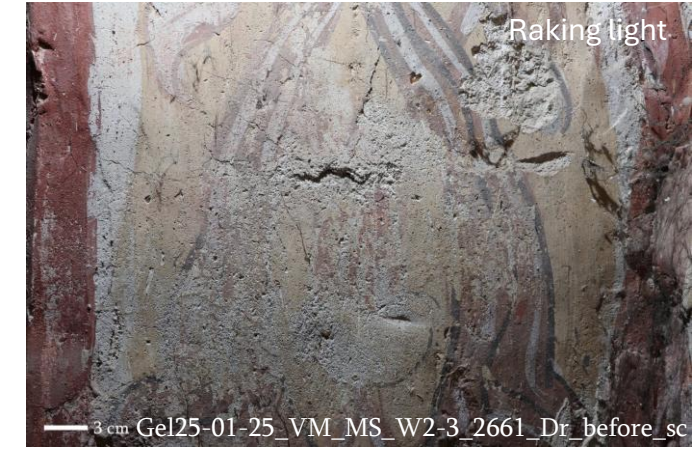
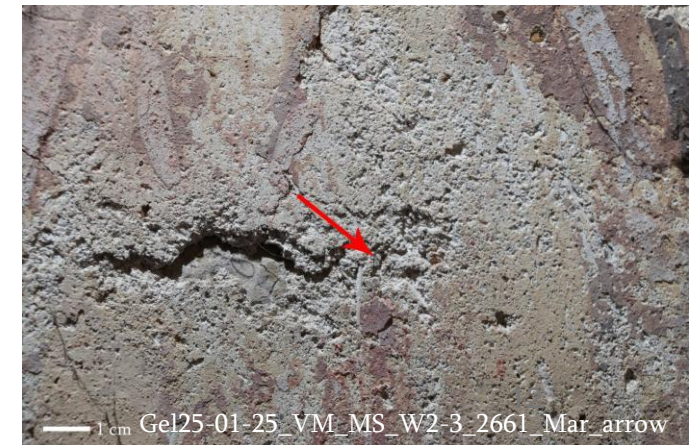
Above and right: South side of the reconstructed window fragment. Thin layer of plaster above the plaster join. The red arrow indicates the location of the microscopic examination of the plaster.

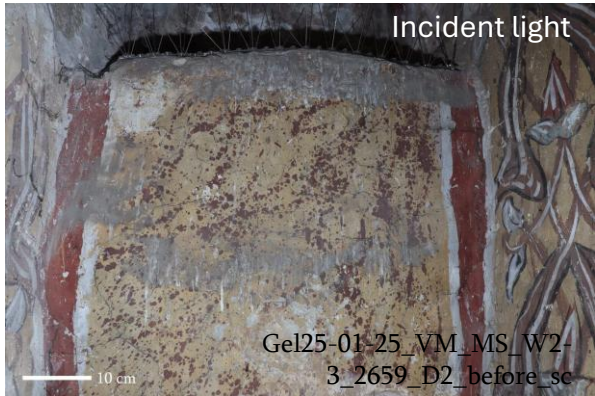
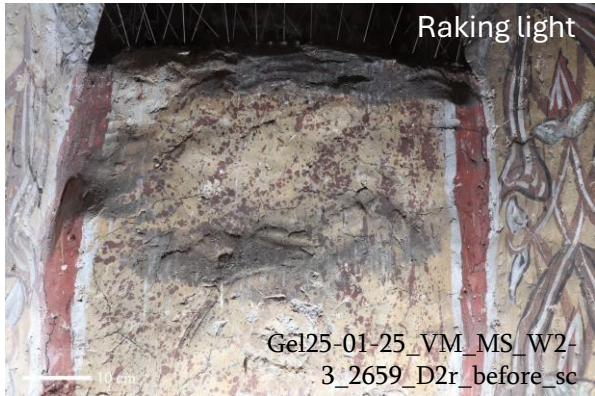
In the study area—specifically on the upper side of the half-meter-deep recessed niche (above the plaster join)—the painting layer is relatively better preserved. The decorative scheme features an imitation of marble, characterized by dense red paint splashes applied over a yellow background, creating a vibrant and textured visual effect.

Left: The upper part of the plaster join has marble imitation on a yellow background with splashes of red paint.

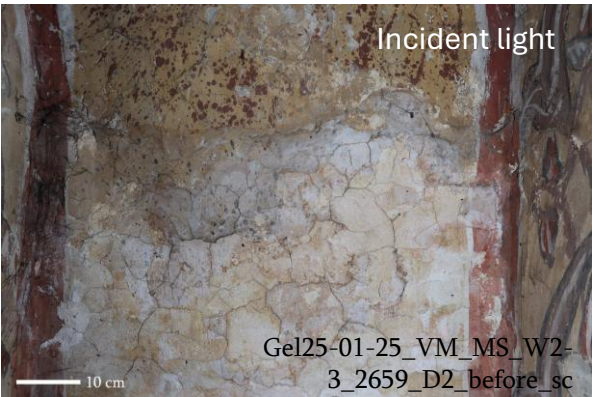
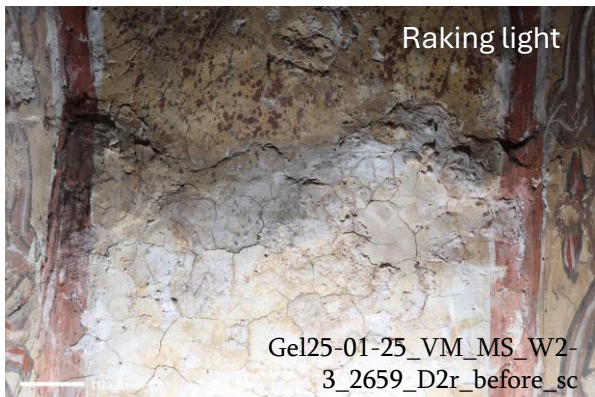
In contrast, on the lower side of the plaster join, the painting layer differs in composition and execution. While the yellow background remains consistent, the decorative elements shift to small black paint splashes, lacking the intensity of the upper section’s red pigments. Along the edges of the painted surface, vertical red and white lines are present, serving to simulate a painted frame, which visually organizes and contains the composition.

Left: And below, the lower part of plaster join has marble imitation on a yellow background with splashes of black paint.

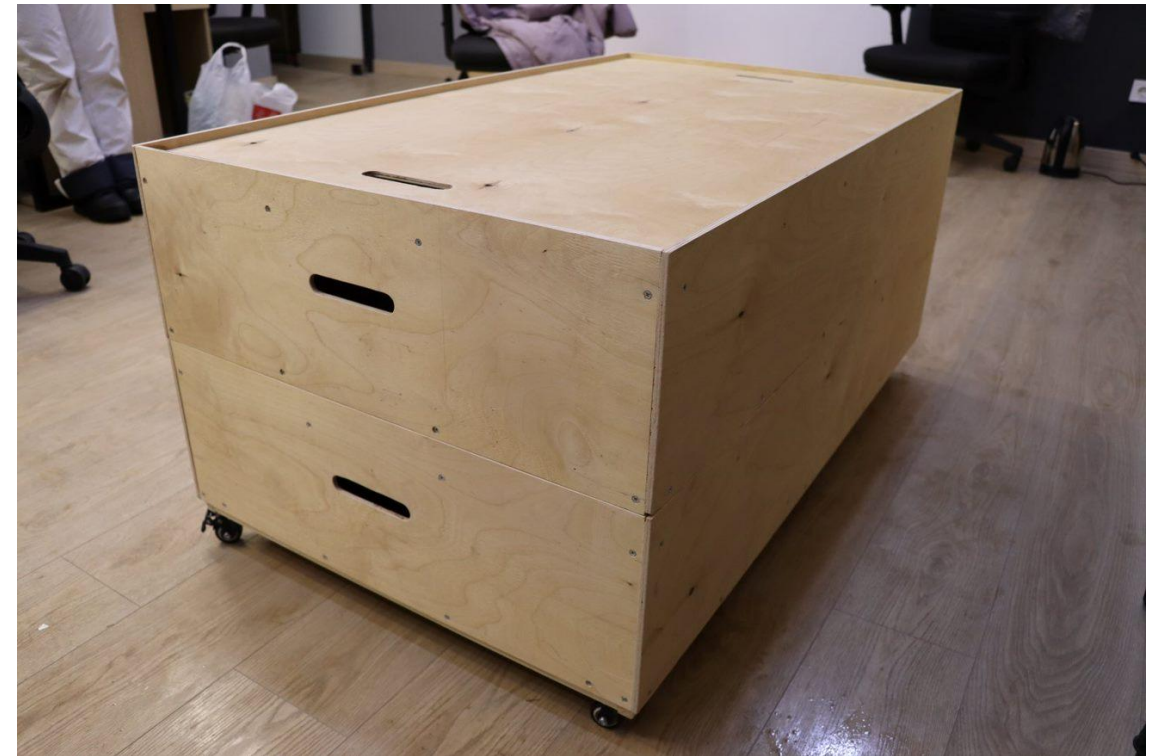
Above: Storage box for the wall painting fragments in the conservation laboratory of the Gelati Monastic Complex.

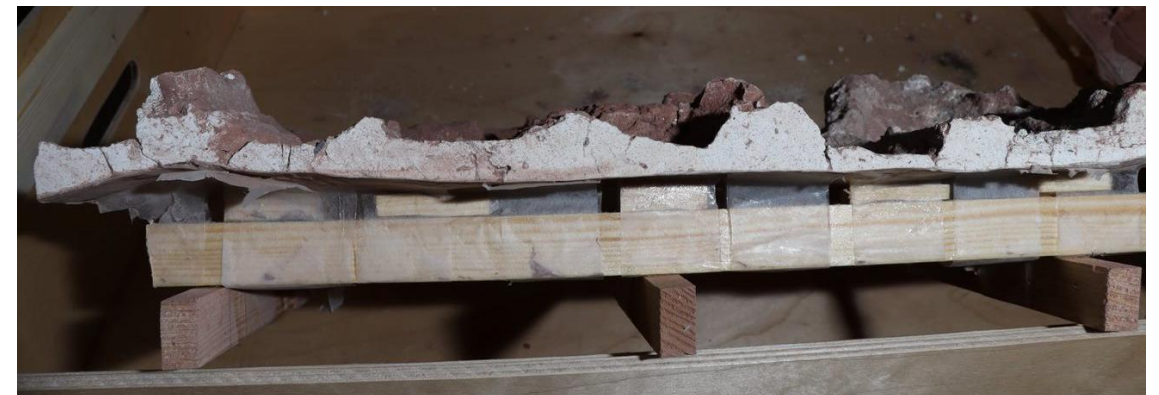
Above: The cut of the removed wall painting fragment.

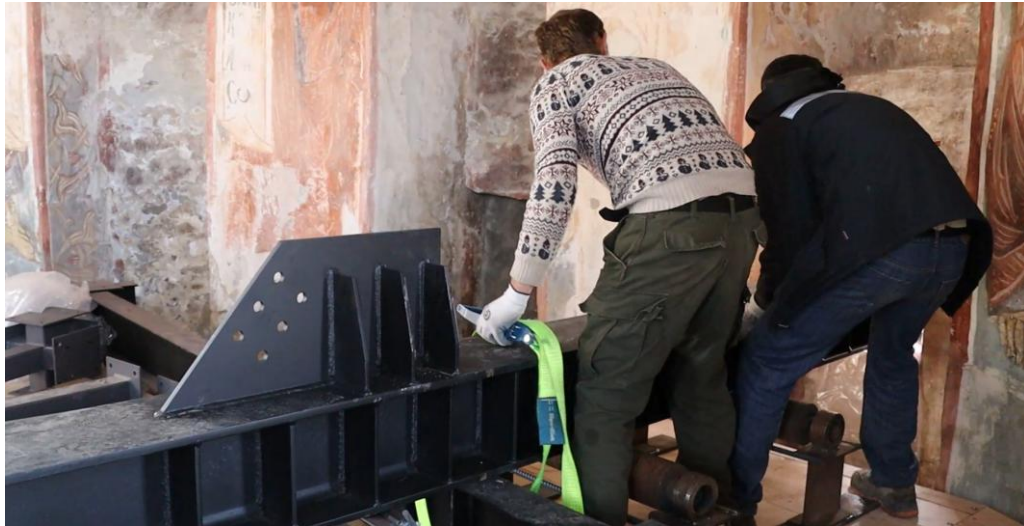
Above: The process of sliding into the opening using the metal construction rails.

The installation of metal poles was carried out under the supervision of the wall painting conservation expert.
