**Safeguarding and conservation of Gelati Monastery
World Heritage Property, Georgia**

Church of the Virgin

**Investigations on the structural hygrometric and micro-environmental
state aimed at safeguarding the internal wall paintings**

Mission Arch. Alessandro Massari of: 06 – 12 November 2021

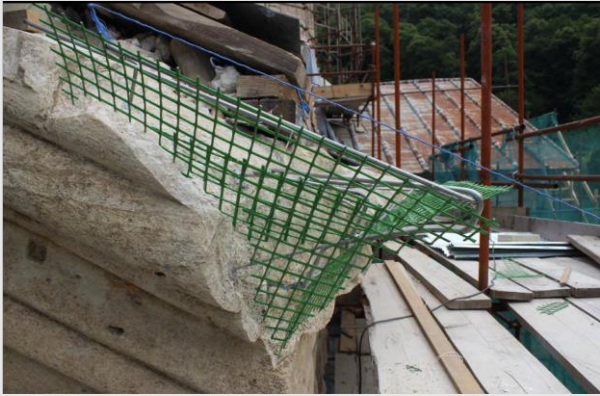
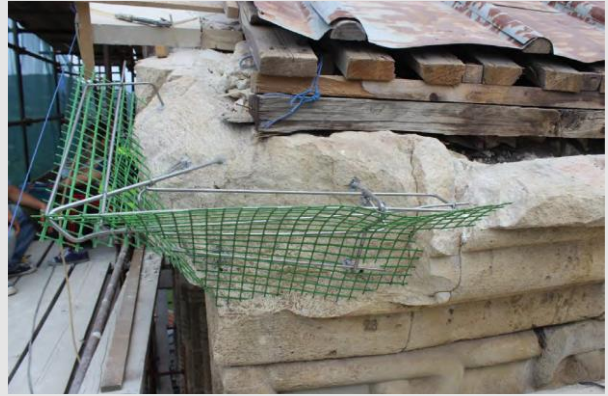
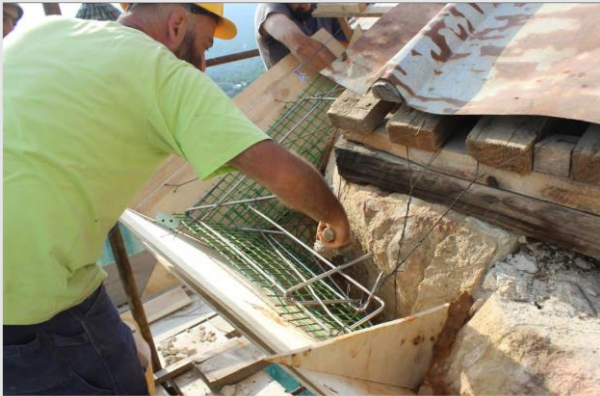
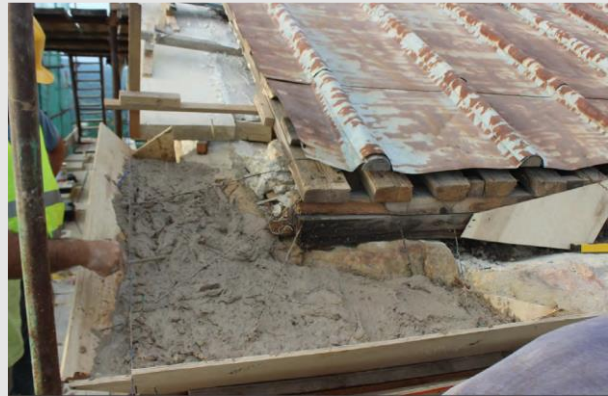
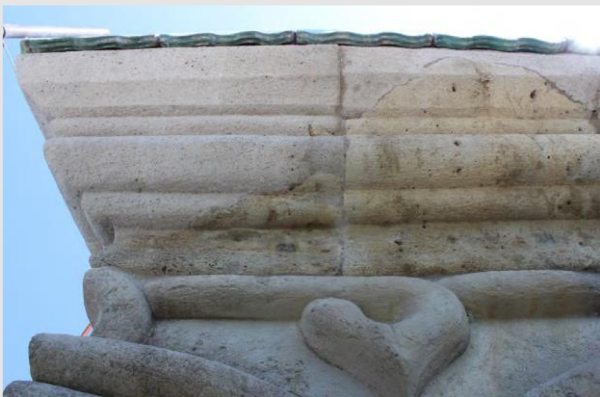
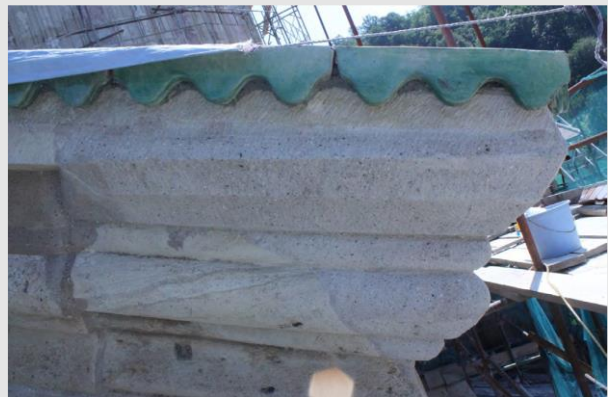
- Rehabilitation of missed part of the cornices with stainless metal and fibre glass and lime mortar (Western Arm)

Adjusted new stone details, were fixed to the existing cornice and stainless-steel belt frame by the fork type anchors. For this procedure the anchoring holes with diameter 6mm and 10 mm were prepared and cleaned by air jet and acetone mixture. Fork type anchors were produced from stainless steel stem of 4mm and 8mm diameter. The anchoring had been conducted with the use of two-component glue (epoxide).

The reconstruction of the relatively less damaged cornice stones was done by lime mortar with

following composition: 1 share lime, 1 share quartz sand, 0,5 share marble powder, 0,5 share black sand, 1 share pozzolana, 0,5 share white stone peddles of middle fraction and fibrous material. In some cases, to gain higher durability, the stainless-steel frames had been arranged inside the plaster.

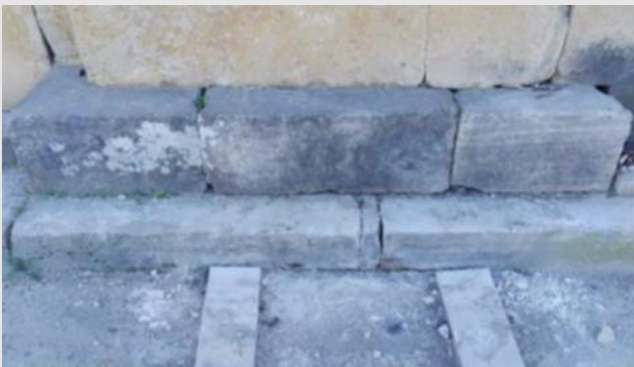
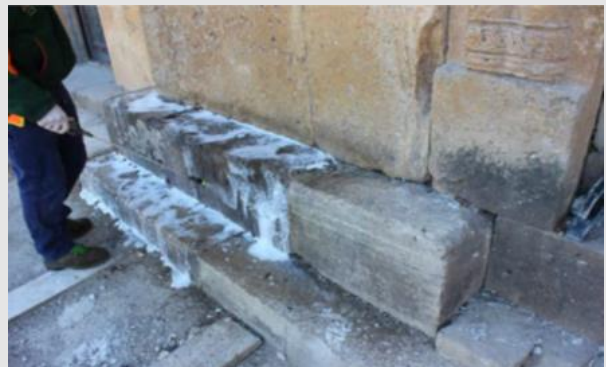
- Treatment with biocide

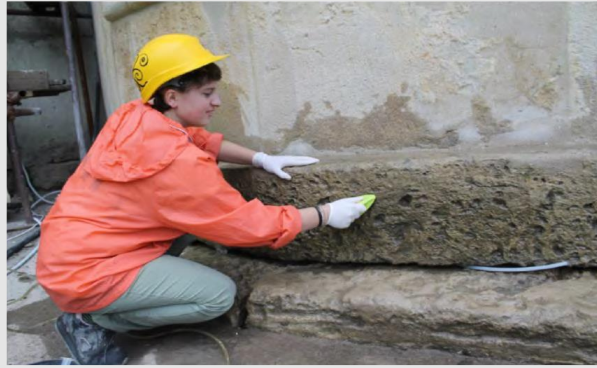
- Mechanical cleaning

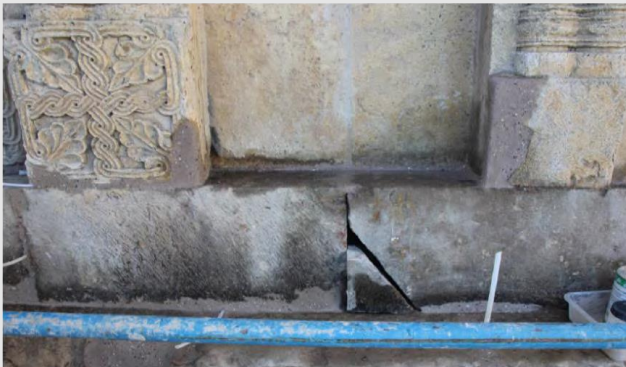
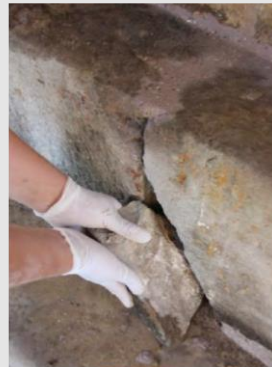
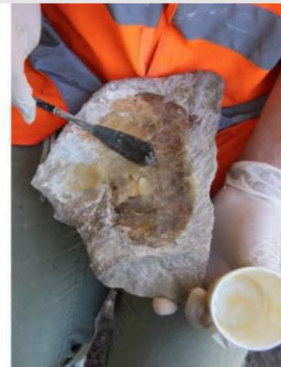
- Unification process of fragmented stone details by epoxide rubber

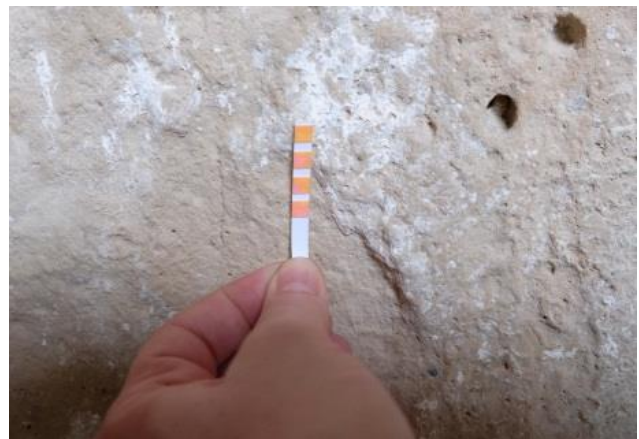
The instrumental survey results reflect a quite heterogeneous situation characterized by a modest presence of moisture in the interior parts of the building and an increased surface humidity along the perimeter walls. This is evidently a quite ordinary distribution of moisture (current or past) contributions from outside, fed by water dispersed around the building. Nonetheless, the gauged moisture has rarely reached high levels which are typical of aggression by infiltration or capillary rise in progress. This indicates a current probable prevalence of the hygroscopic component over the capillary or infiltration component. To assess the presence of hygroscopic salts, several semi-quantitative-immediate-response-tests were performed where the instrumental survey has indicated as wet. The outcomes span from positive to very positive for nitrates, whereas in the case of sulphates it varies from very positive to negative (*figures 25 and 26*). Conversely, results were negative in areas found to be dry during the instrumental survey.

Figure 26: Test S2 (env. 7)

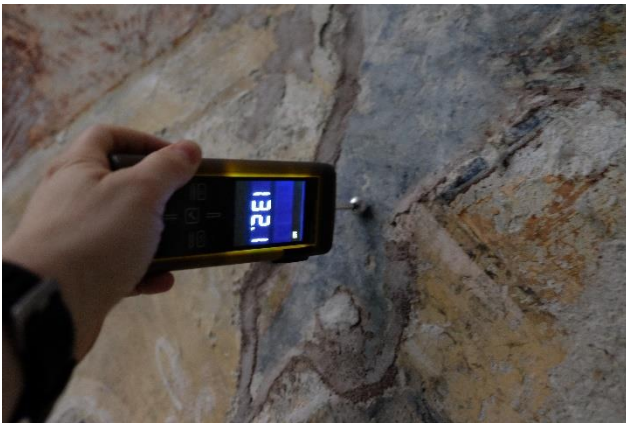
Figure 27: hygrometric measurements by portable instrument

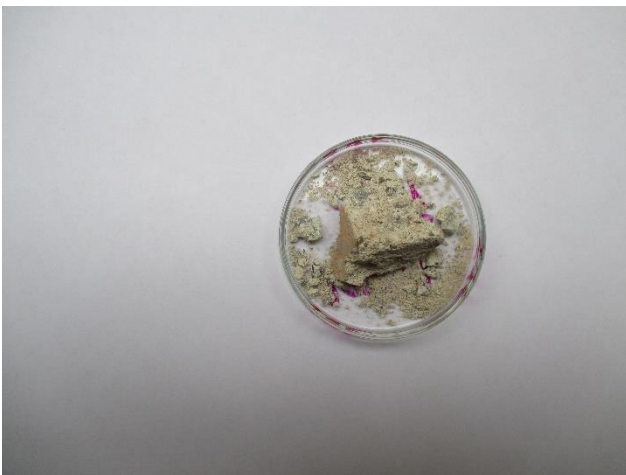
*Figure 42: Point **GB**, sample 30, layer for tiles nailing*
